DOE/NASA/20370-23
NASA TM-102378

Model 0A Wind Turbine Generator FMEA

Prepared for the
1990 Annual Reliability and Maintainability Symposium
cosponsored by the ASME, ASQC, IIE, IEEE, SOLE,
IES, AIAA, SSS, and SRE
Los Angeles, California, January 23-25, 1990

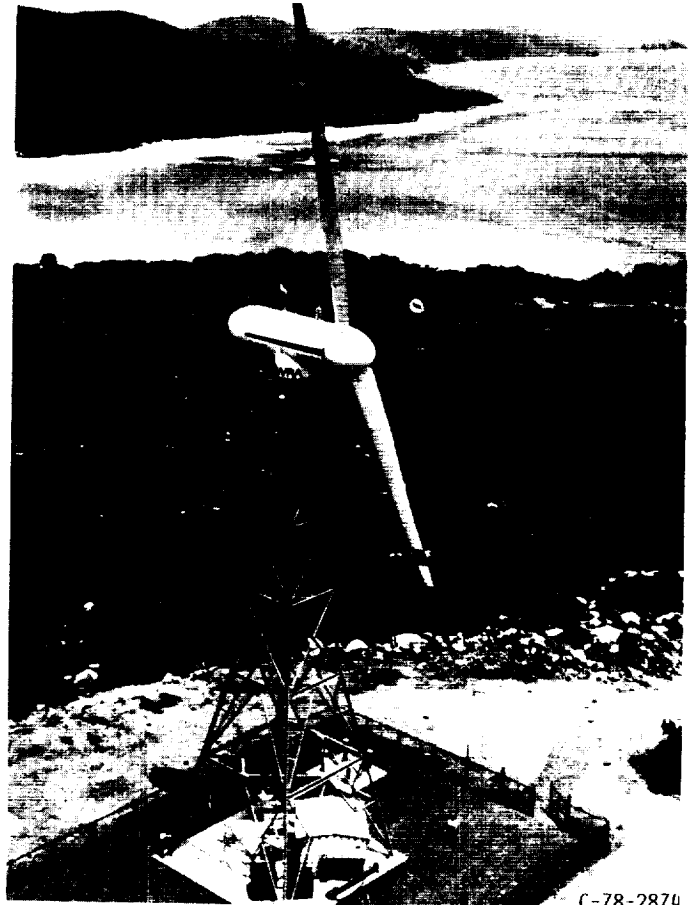
FIGURE 1. - MOD OA WIND TURBINE AT CULEBRA ISLAND, PUERTO RICO.

A photograph of one MOD-OA machine, located on Culebra Island, Puerto Rico, is shown as Fig. 1. Nearly identical machines were located in Clayton, New Mexico, Block Island, Rhode Island, and Oahu, Hawaii. The blades measured 125 ft, tip-to-tip. The hub center was 100 ft above ground level. The blades rotated at 40 rpm. The blades were mounted on the rotor hub, as shown in the cutaway drawing included as Fig. 2. The pitch actuator pitched the blades through a set of bevel gears located inside the hub. The hub was attached to a low-speed shaft which was connected to a speed increaser gearbox. A fluid coupling, attached to the 1800 rpm output shaft of the gearbox helped dampen out power oscillations. A high-speed shaft then transmitted power to V-belts which drove a synchronous alternator. The machine was housed in an 8-ft diameter nacelle.

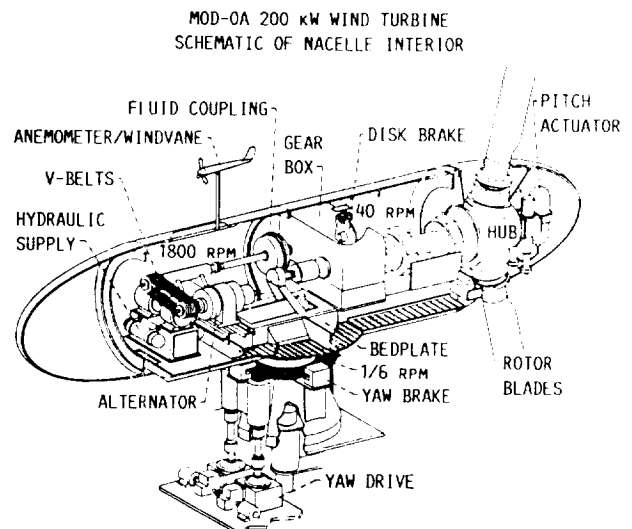
FIGURE 2. - CUTAWAY DRAWING OF TOWER MOUNTED EQUIPMENT.
